# Can One Machine Clean All Permeable Pavements?

David R. Smith<sup>1</sup> and Donald Rissmeyer, PE, CFM<sup>2</sup>

## Abstract

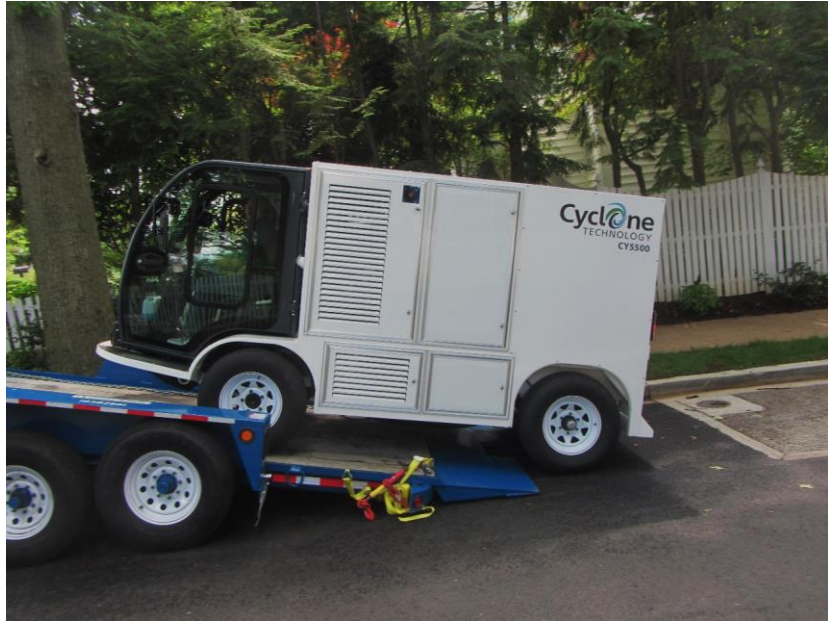
**Figure 1. A Cyclone CY5500 machine used in this test experiment**

The equipment used was a Cyclone CY5500 powered by a diesel engine. The machine was brought to the site on a trailer towed by a heavy-duty pickup truck. Cyclone manufactures a smaller walk-behind model and a larger truck-size version. This cleaning was done by an off-road vehicle smaller than the truck-size equipment.

The equipment was originally developed to remove tire rubber from airfield runways. This machine carries approximately 1200 liters (300 gal) of water much of which is drawn back into the machine, filtered and re-used.

The Cyclone machine relies on water applied in a circular motion within a surrounding chamber in close contact with the permeable pavement surface. The water pressure can be varied by the operator from 8 MPa (1, 200 psi) to 30 MPa (4,350 psi). The water is blasted against the pavement surface and the speed of the rotating head applying the water provides some suction (hence the cyclone name) to pull the most of the water back into the machine where it is filtered for re-use. The machine manufacturer claims cleaning rates as high as approximately 935 square meters (10,000 sf) per hour on most permeable pavements. A picture of the machine is in Figure 1 below.

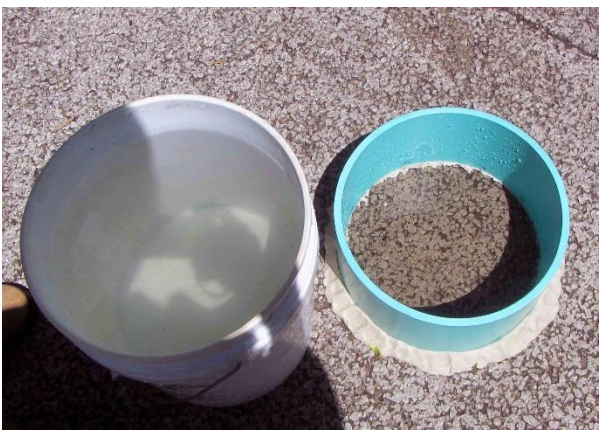
**Figure 2. Initial or pre-wetting test using ASTM C1701 on pervious concrete parking lane. Note the standing water due to a clogged surface.**

The four areas were cleaned in the following order: cast-in-place PC, PICP, PA, then the precast PC panel. Prior to conducting cleaning, ASTM C1701 *Standard Test Method for Infiltration Rate of In Place Pervious Concrete* and C1781 *Standard Test Method for Surface Infiltration Rate of Permeable Unit Pavement Systems* was applied to each surface. The former test method is applicable to porous concrete and both methods produce comparable results. Both ASTM test methods label the initial test procedure “pre-wetting” to determine the extent of surface clogging. This is done by applying approximately 5 kg (8 lbs) (roughly equivalent to 5 liters (1 gal)) of water into a 30 cm (12 in.) diameter ring sealed to the pavement with plumber’s putty and while maintaining an approximate head of 10 mm (3/8 in.). This is illustrated in Figures 2 through 5.

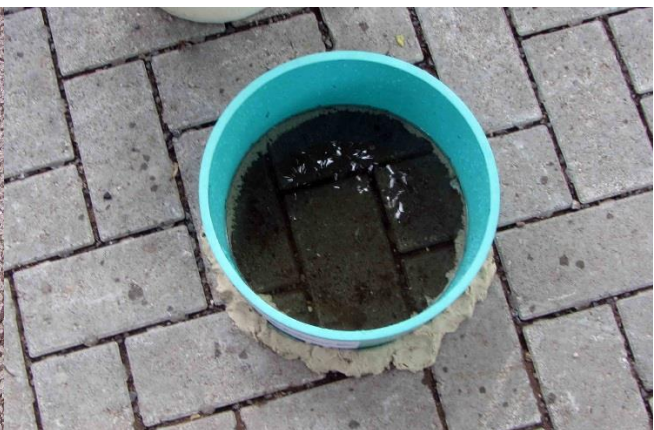
**Figure 3. Initial or pre-wetting test using ASTM C1781 permeable interlocking concrete pavement alley. Standing water indicates a clogged surface.**

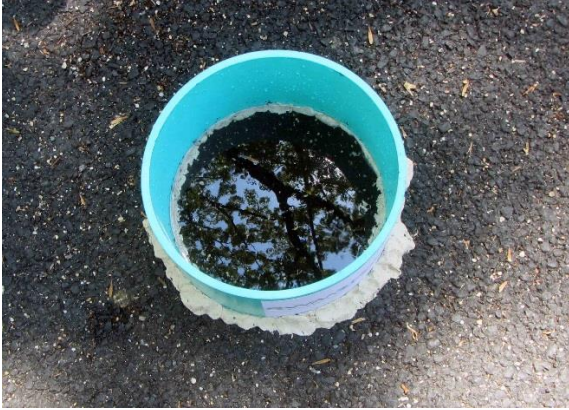
**Figure 4. Initial or pre-wetting test using ASTM C1701 on porous asphalt alley. Note the standing water due to a clogged surface.**

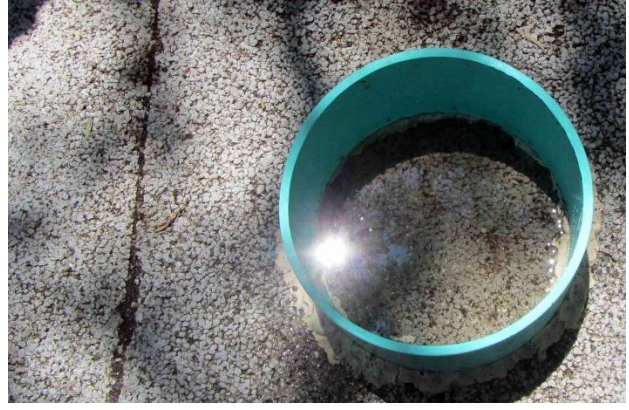
**Figure 5. Initial or pre-wetting test using ASTM C1701 on pre-cast pervious concrete panel in the street parking lane. Note the standing water due to a clogged surface.**

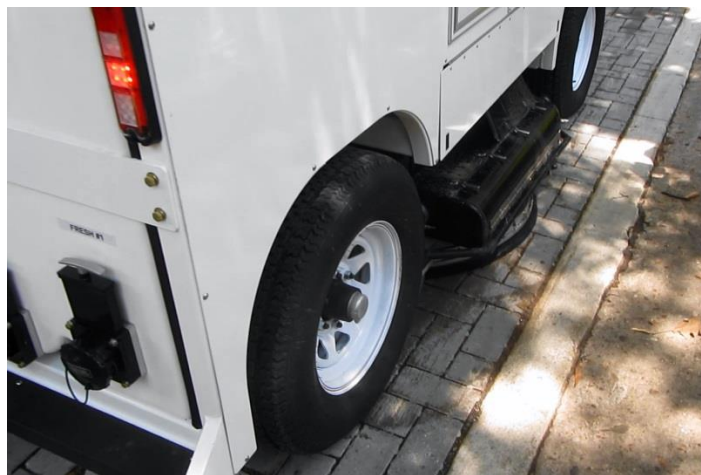
**Figure 6. The Cyclone machine cleaning a PICP alley.**

If the pre-wetting water applied into the ring requires more than 120 seconds to completely infiltrate, then the same amount of water (5 liters) is applied 2 minutes later. Procedures in this experiment deviated from the ASTM procedures by having the Cyclone machine pass twice over the same area of permeable pavement almost immediately after the pre-wetting was completed, requiring a few minutes of time. The pre-wetting initial infiltration test measurement was conducted to determine the extent of clogging. Figure 6 show the Cyclone machine making a typical pass of about 10 m.

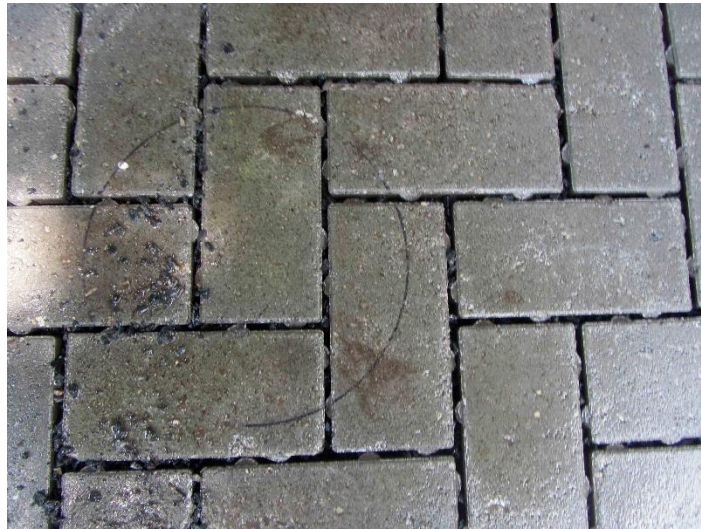
**Figure 6. PICP after two passes of the Cyclone machine. Note aggregate and sediment removed resulting in open joints.**

The most notable observation is that the PICP only required two passes of the Cyclone machine rather than four to increase the infiltration rate from <508 mm/hr (20 in./hr) to 8306 mm/hr (327 in./hr). The joints widths in the PICP were narrow, approximately 6 mm (1/4 in.) wide and many of the small aggregates were pulled out with the sediment after the first two passes. Some of the stones were left on the surface of the pavers after the second pass and these could be swept back into the joints. See Figure 6. Additional aggregate should probably be supplied given these results, as that is the recommendation by Eisenberg (2015) in the ASCE book, *Permeable Pavements*, Chapter 8.
