# TECH SPEC

NUMBER 7

## Repair of Utility Cuts Using Interlocking Concrete Pavers

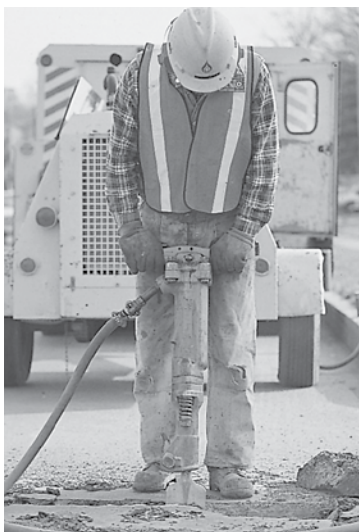
Figure 1. Repairs to utilities are a common sight in cities, incurring costs to cities and taxpayers.

North American cities have thousands of utility cuts made in their streets each year. Figure 1 shows a daily occurrence in most cities: repairs to underground utility lines for water, sewer, gas, electric, steam, phone, fiber-optic, or cable services. A sample is given below of the number of annual utility cuts in a few cities.
